RE: Madison Ave & Hilliard Road – Safety Analysis Study (Iteris)

Madison Ave & Hilliard Rd/Carabel Ave Safety Analysis Study

Final Version
January 2026

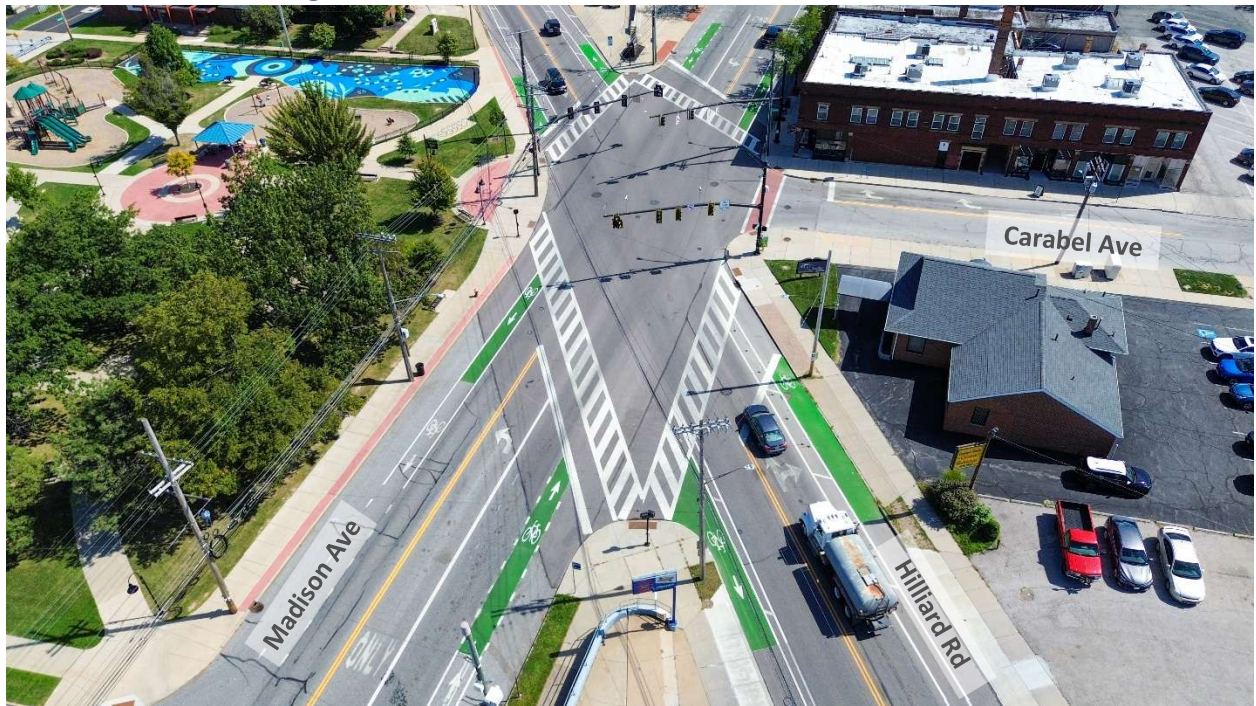
Figure 2 – Madison Ave & Hilliard Rd/Carabel Ave Aerial View

Madison Ave and Hilliard Rd/Carabel Ave is a five-leg signalized intersection. Madison Ave is an east to west corridor that extends through the entire City. Hilliard Rd is a northeast to southwest corridor that starts in the southwest portion of the City and extends northeast to Franklin Blvd/Warren Rd. Figure 2 is an aerial image of the existing intersection.

The study intersection of Madison Ave & Hilliard Rd/Carabel Ave is characterized by a skewed angle of approximately 35 degrees between Hilliard Rd and Madison Ave creating a wide footprint. This alignment significantly increases crossing distances for pedestrians, in some cases extending beyond standard thresholds recommended for urban signalized locations. The longer crossing paths elevate pedestrian exposure times and require extended clearance intervals, thereby reducing operational efficiency and safety.

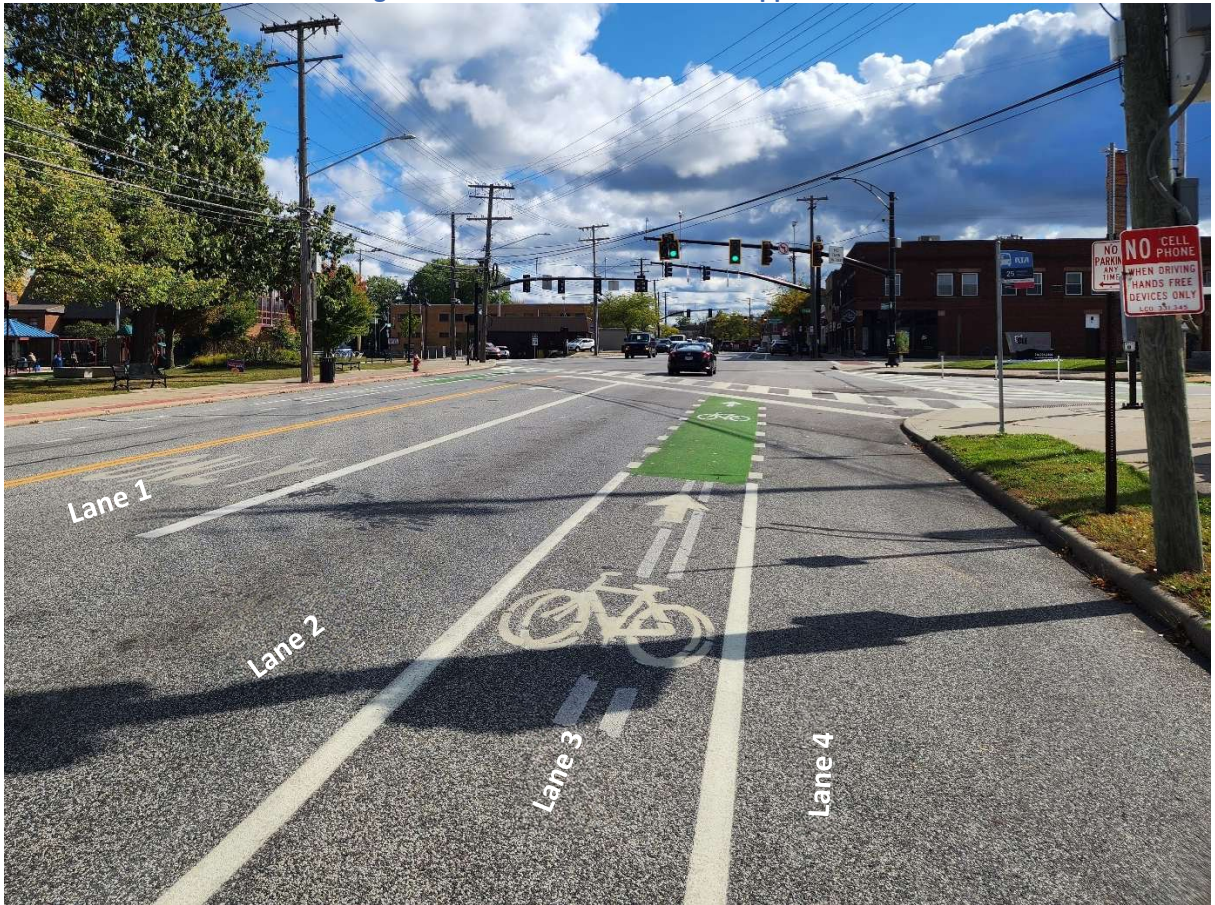
Figure 3 – Madison Ave Eastbound Approach

- Madison Ave Eastbound Approach (refer to **Figure 3**)
 - **Lane 1** (inside): Exclusive left-turn only lane, developed from the upstream two-way left-turn lane (TWLTL), approximately 11' wide.
 - **Lane 2** (middle): Shared through/right-turn lane, approximately 11' wide.
 - **Lane 3** (outside): Exclusive bicycle lane, extending to the intersection stop line and is approximately 4' wide. The bicycle lane is channelized with a solid white line and transitions to a skip line approximately 130' away from the stop bar.
 - **Lane 4** (curbside): Exclusive on-street parking lane, located to the right of the bicycle lane.
 - The eastbound left turn is a 5-section protected/permissive left turn movement.
 - The approach is signed to prohibit right turns on red.

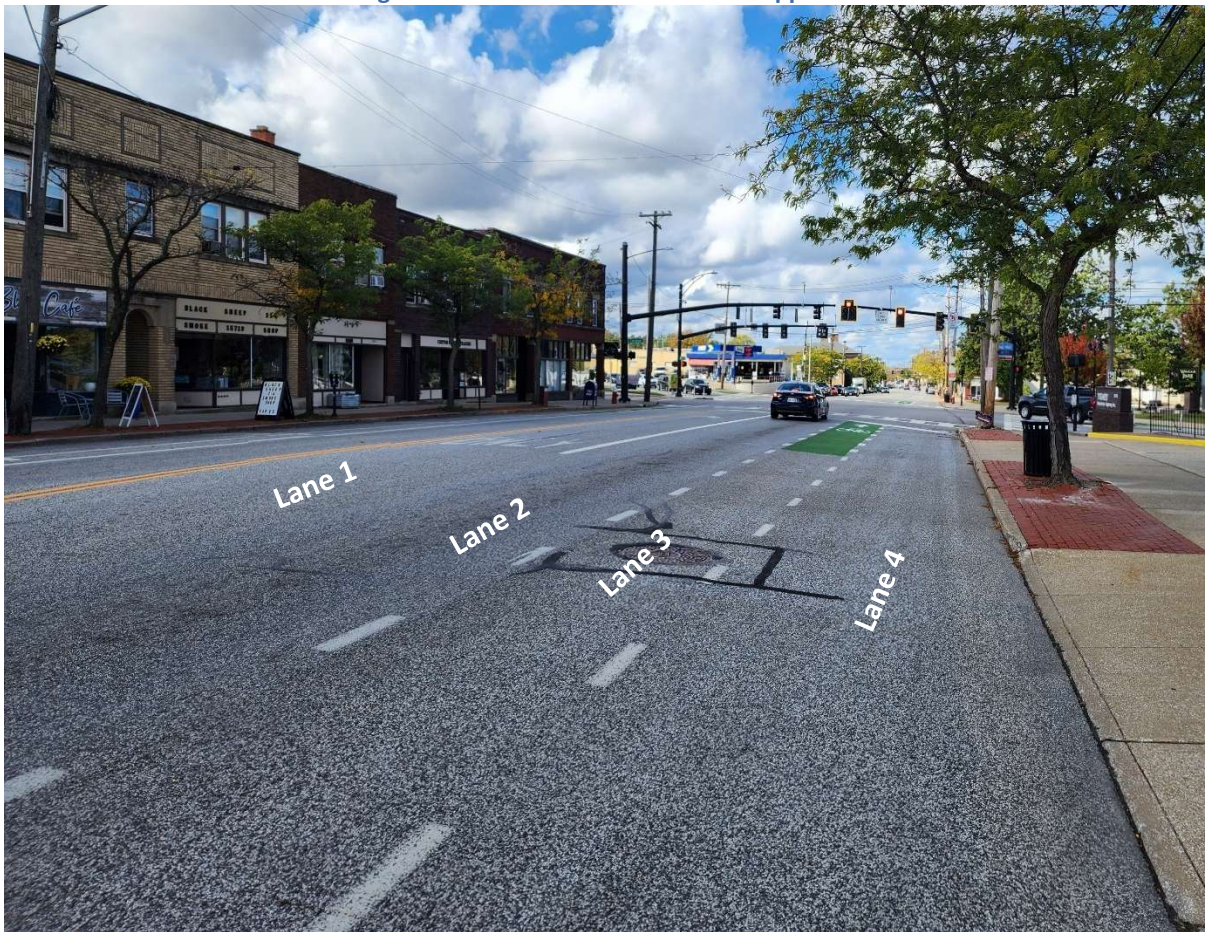
Figure 4 – Madison Ave Westbound Approach

- Madison Ave Westbound Approach (refer to **Figure 4**)
 - **Lane 1** (inside): Exclusive left-turn only lane, developed from the upstream two-way left-turn lane (TWLTL), approximately 11' wide.
 - **Lane 2** (middle): Shared through/right-turn lane, approximately 11' wide.
 - **Lane 3** (outside): Exclusive bicycle lane, extending to the intersection stop line and is approximately 4' wide. The bicycle lane is channelized with a solid white line and transitions to a skip line approximately 130' away from the stop bar.
 - **Lane 4** (curbside): Exclusive on-street parking lane, located to the right of the bicycle lane.
 - The westbound left turn is a 5-section protected/permissive left turn movement.
 - The approach is signed to prohibit right turns on red.

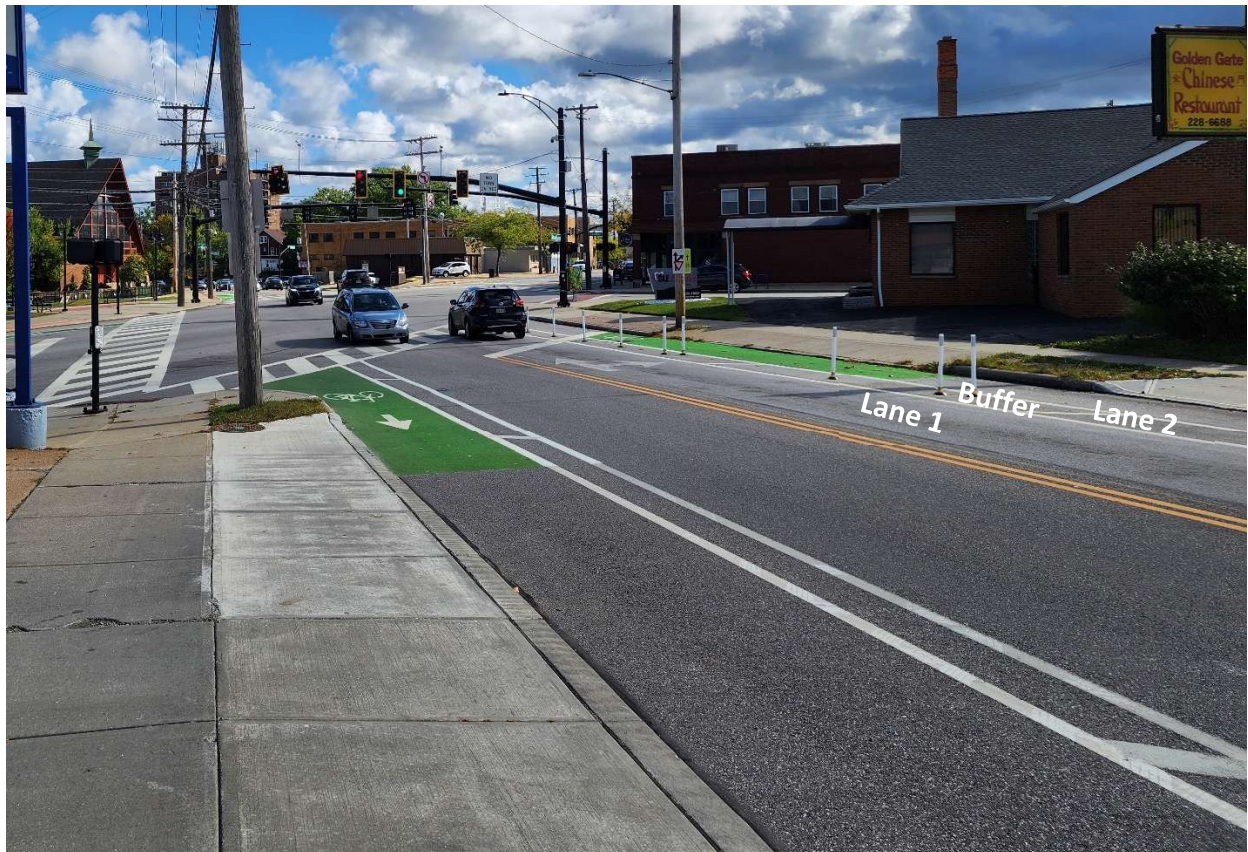
Figure 5 – Hilliard Rd Northeast Approach

- Hilliard Rd Northeast Approach (refer to **Figure 5**)
 - **Lane 1** (inside): Single lane for the through and shared with the right turn movement. Left turn and U-Turn movements are prohibited.
 - **Lane 2** (curbside): A dedicated bicycle lane approximately 4 feet wide, extending to the intersection stop line. It includes a 2-foot painted buffer separating it from the adjacent through/right vehicle lane. Near the intersection, the lane is highlighted with green pavement markings. Flexible delineators have been installed by the City in the buffer lane to provide physical separation between the bike lane and the adjoining travel lanes.
 - The approach is signed to prohibit right turns on red.

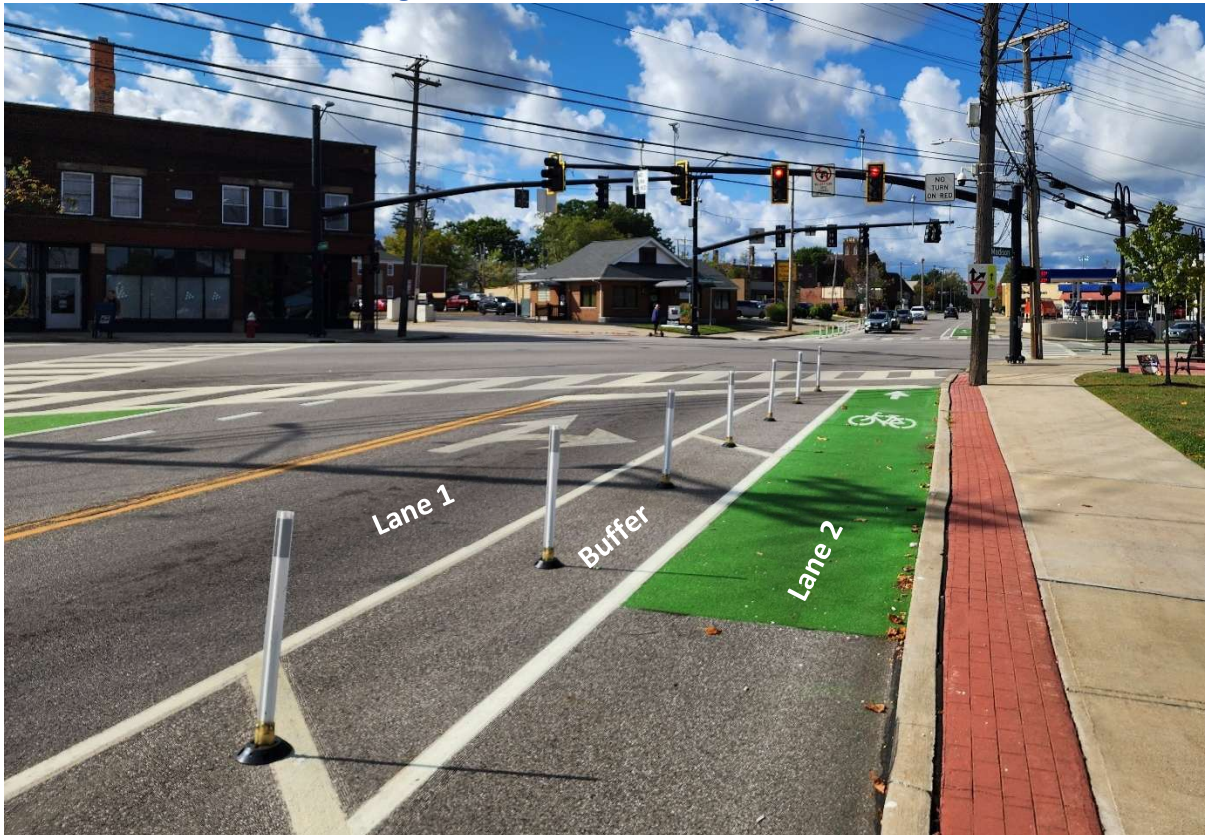
Figure 6 – Hilliard Rd Southwest Approach

- Hilliard Rd Southwest Approach (refer to **Figure 6**)
 - Lane 1 (inside): Single lane for the through and shared with the right turn movement. Left turns and U-Turn movements are prohibited.
 - Lane 2 (curbside): A dedicated bicycle lane approximately 4 feet wide, extending to the intersection stop line. It includes a 2-foot painted buffer separating it from the adjacent through/right vehicle lane. Near the intersection, the lane is highlighted with green pavement markings. Flexible delineators have been installed by the City in the buffer lane to provide physical separation between the bike lane and the adjoining travel lanes.
 - The approach is signed to prohibit right turns on red.

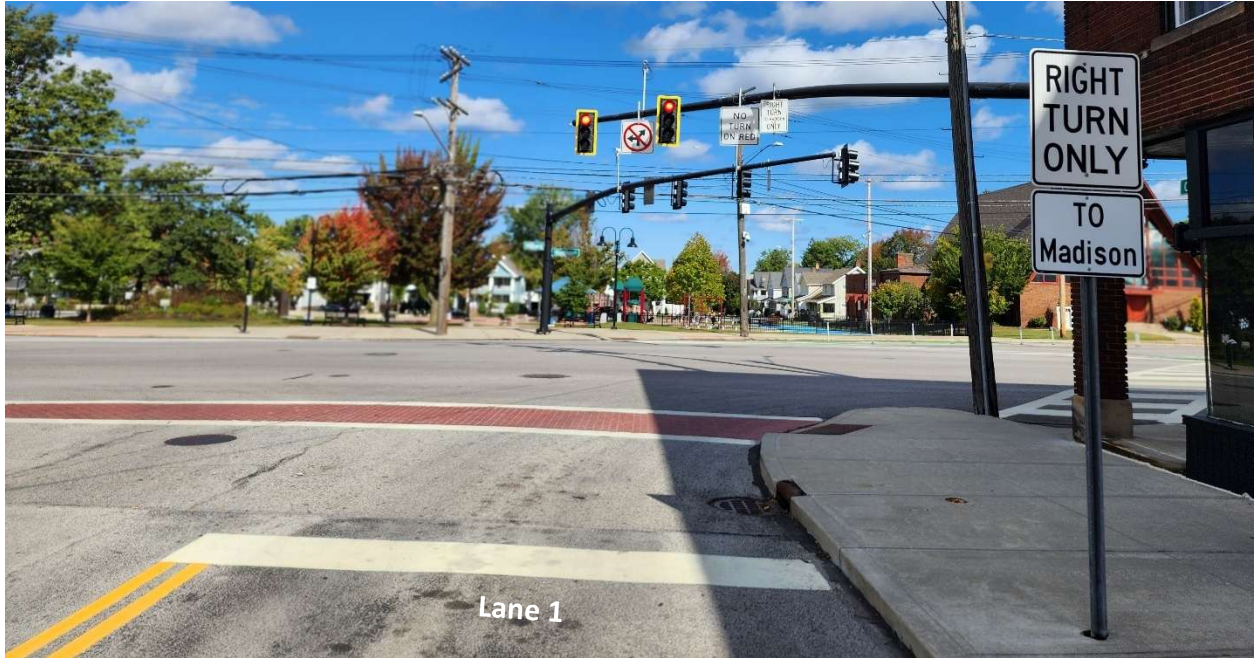
Figure 7 – Carabel Ave Northbound and Southbound

- Carabel Ave Northbound Approach and Southbound (refer to **Figure 7**)
 - **Lane 1:** Carabel Ave is a signal lane approach and only allows northbound right turns onto eastbound Madison Ave.
 - The northbound right movement operates during the same phase as the westbound left from Madison to Hilliard Rd/Carabel Ave.
 - The approach is signed to prohibit right turns on red.

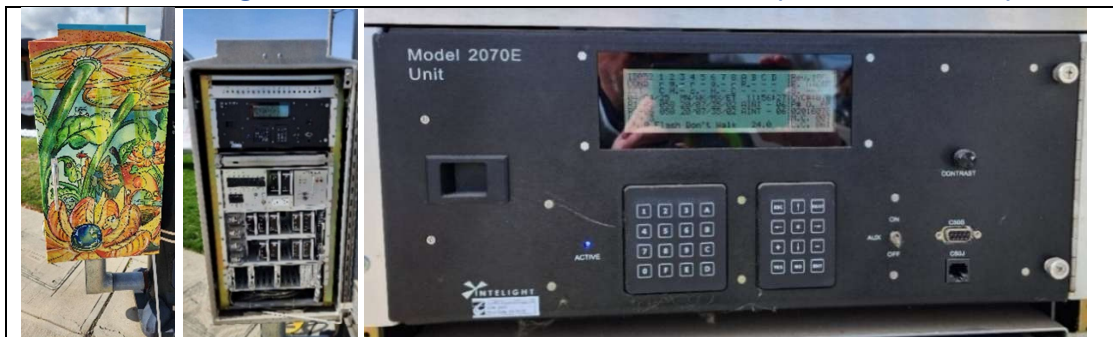
Figure 8 – Madison Ave & Hilliard Rd/Carabel Ave (2070 controller Unit)

Existing controller data was obtained from the City via an upload from the central platform, Trafficview 32. The intersection is a model 2070E with Wapiti firmware (see **Figure 8**). The existing signal layout and traffic signal phasing is shown in **Figure 9**.

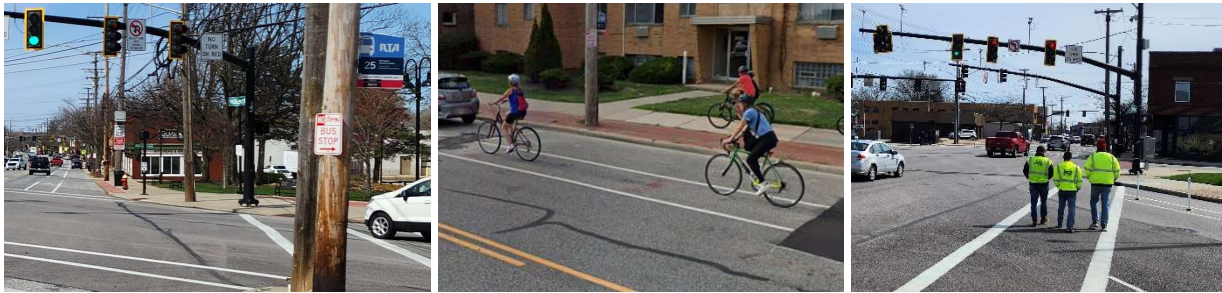
Figure 10 – Study Area Bus, Bicycle and Pedestrian Activity

The study area is very inviting to pedestrian activity with the land use mixes near the intersection from commercial, business, restaurants, community, recreational, school, and other attractions. On the northwest corner is Wagar Park. The adjacent land uses to the north and south is primarily residential. Sidewalks exist throughout the study area. Crosswalk pavement markings are currently present on all approaches and are transverse (parallel) white lines (see **Figure 10**).

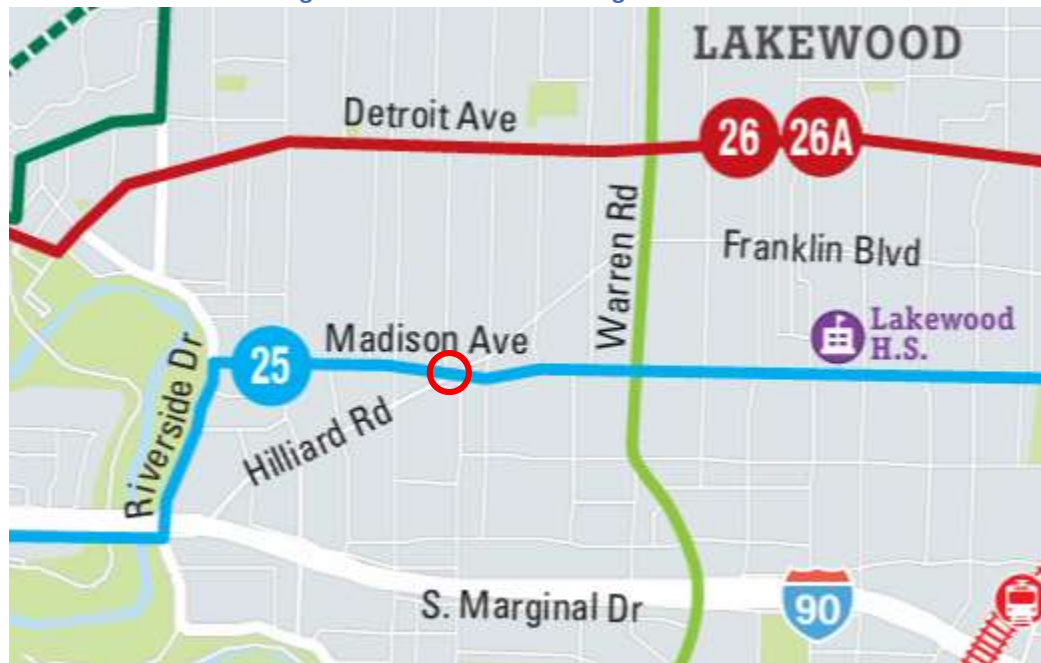
Figure 12 – RTA Route 25 along Madison Ave

Figure 12 illustrate these RTA routes in the study area.

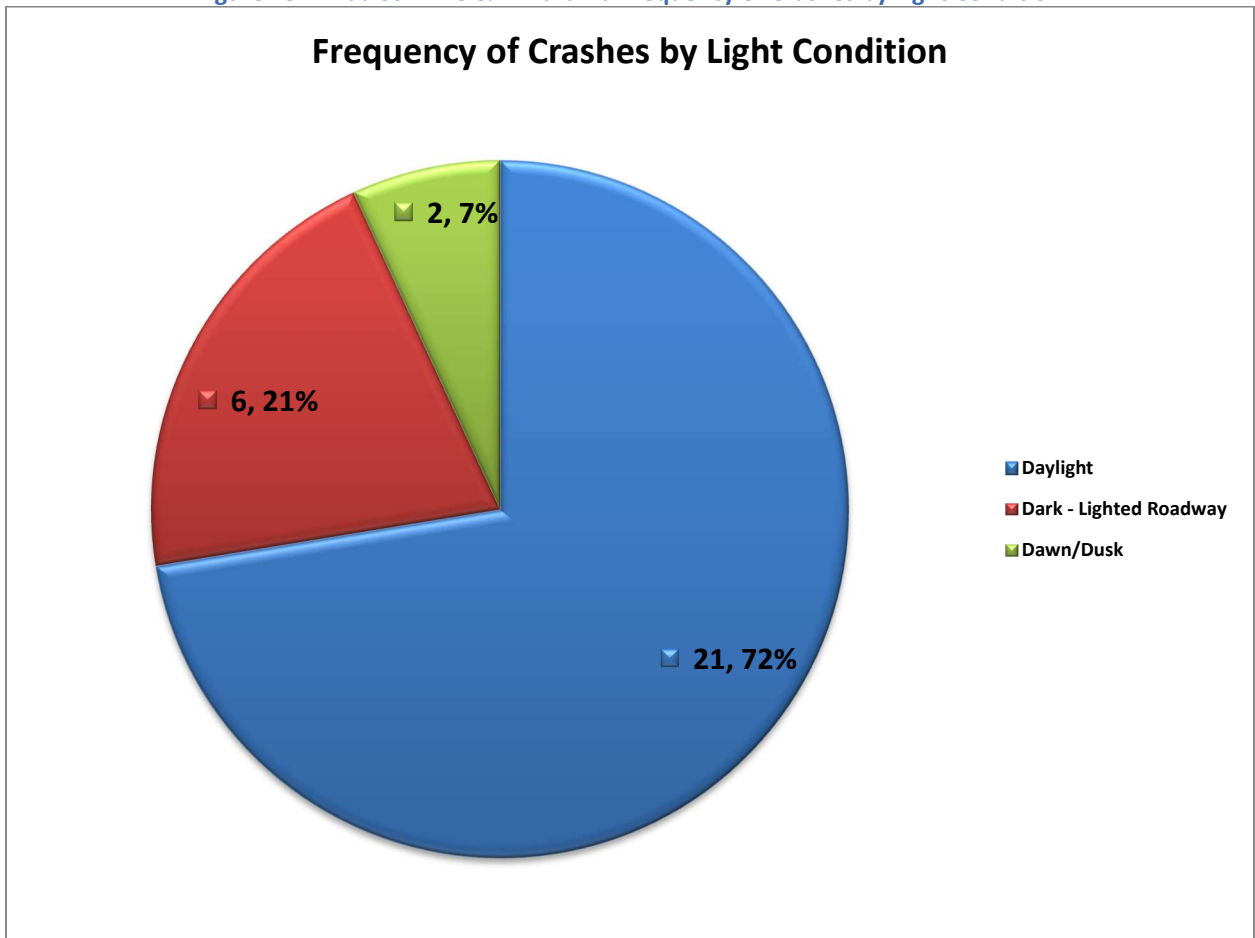
Figure 15 – Madison Ave & Hilliard Rd Frequency of Crashes by Light Condition

Figure 15 illustrates the historical crashes of crashes by light condition.

Analysis shows that 72% of crashes occur during daytime hours, which is not uncommon given that traffic volumes are significantly higher during this period. The fatal accident did occur during dark (lighted) roadway conditions with wet pavement.

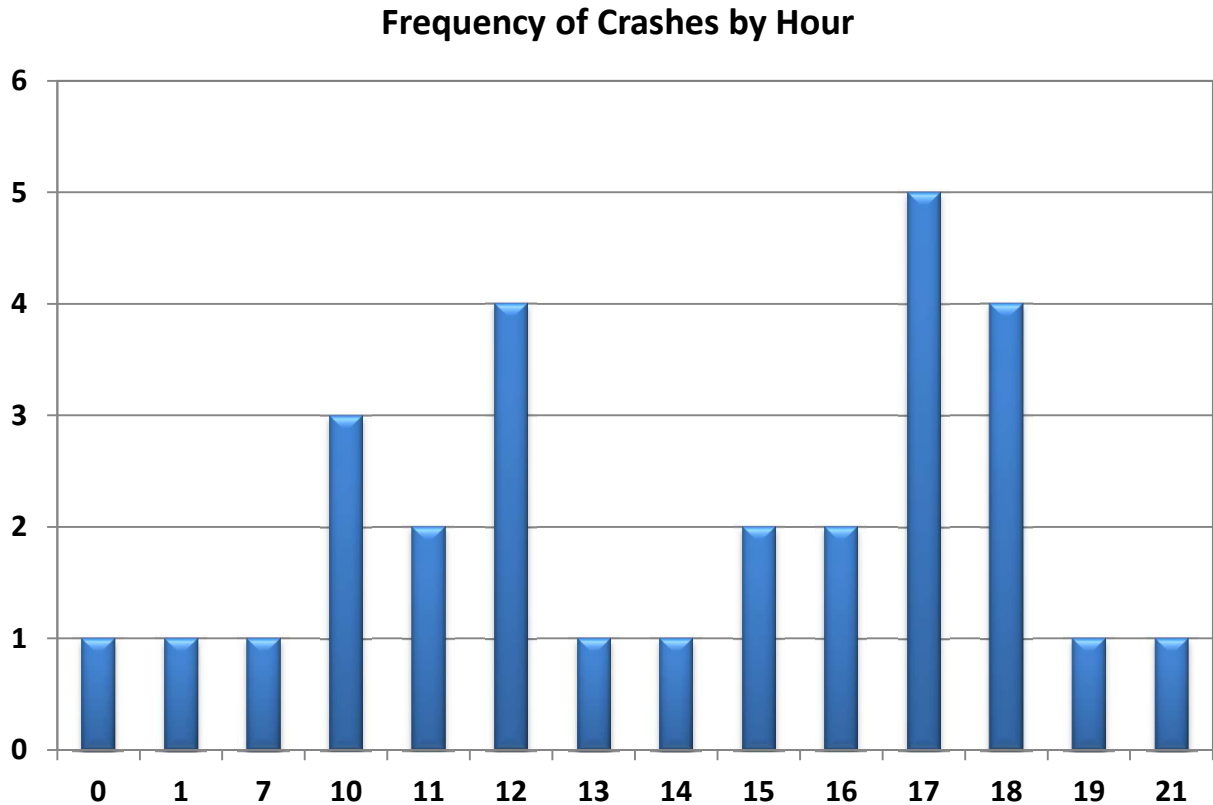
Figure 16 – Madison Ave & Hilliard Rd Frequency of Crashes by Hour of the Day

Figure 15 illustrates the historical crashes of crashes by hour of the day.

Crash data by time of day shows a clear concentration during daylight and early evening hours. Crash frequency began to rise mid-morning, with three crashes at 10 a.m. and two at 11 a.m., peaking around midday with four crashes at noon. Afternoon activity remained steady, with one to two crashes reported each hour between 1 p.m. and 4 p.m. The highest frequency occurred at 5 p.m. with five crashes, followed by four crashes at 6 p.m. After 7 p.m., only sporadic incidents were recorded, with one crash each at 7 p.m. and 9 p.m. Overall, the majority of crashes occurred between late morning and early evening, coinciding with peak traffic volumes.

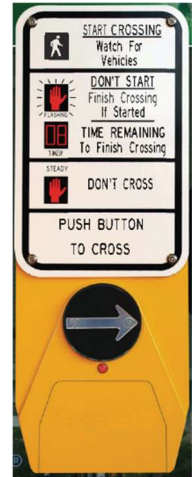
If LPI is implemented as recommended above, APS is highly desirable for visually impaired individuals as they use verbal cues from adjacent vehicles to know when the walk indication is on if there is no APS.

In general, this would be moderate cost provided additional structural items are not required, but this is not anticipated. APS is recommended, in particular with the addition of LPI.

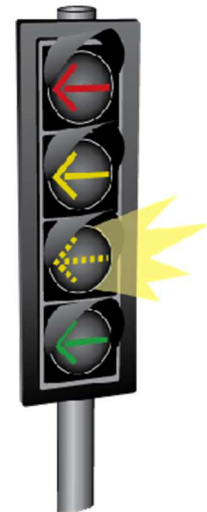
The FYA has been widely adopted and even encouraged by agencies across the United States. ODOT has embraced the use of the FYA and more information can be found here, <https://www.transportation.ohio.gov/programs/tsmo/signals/flashing-yellow-arrow>. The FYA indication would allow for the operation of an LPI for pedestrians crossing Hilliard Rd.

The cost of the FYA at the subject location should be moderate to high. The structure is capable of centering the new indication over the left turn lanes. However, the cabinet and controller would likely need to be updated.

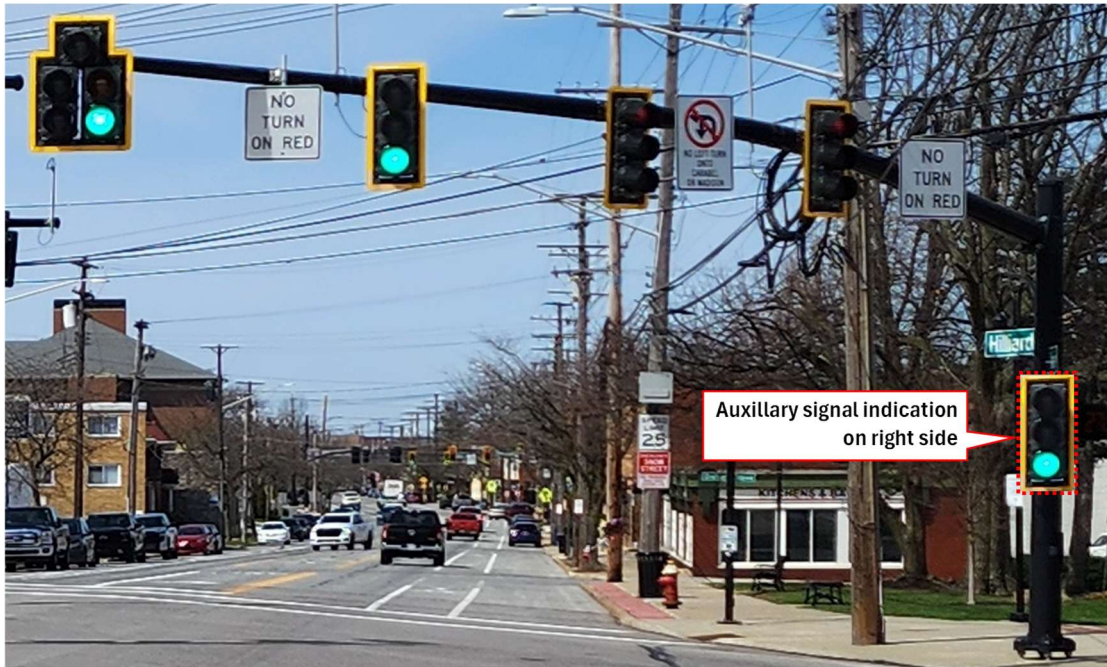
Figure 18 – Auxiliary Right Side Signal Indication

An auxiliary right side signal indication is installed on the right side upright of the traffic signal structure. Large trucks often block the view of the overhead signal indications and these auxiliary signals help improve visibility for these locations. Figure 18 illustrates the approximate location of a proposed auxiliary right side signal indication. These indications at this location could be misleading for opposing directions due to the skewed angle between Madison Ave and Hilliard Rd. These are not recommended for the short-term, but in the long term if signal structures are updated, these could be installed on near-side upright poles that would not be visible to the other approaches.

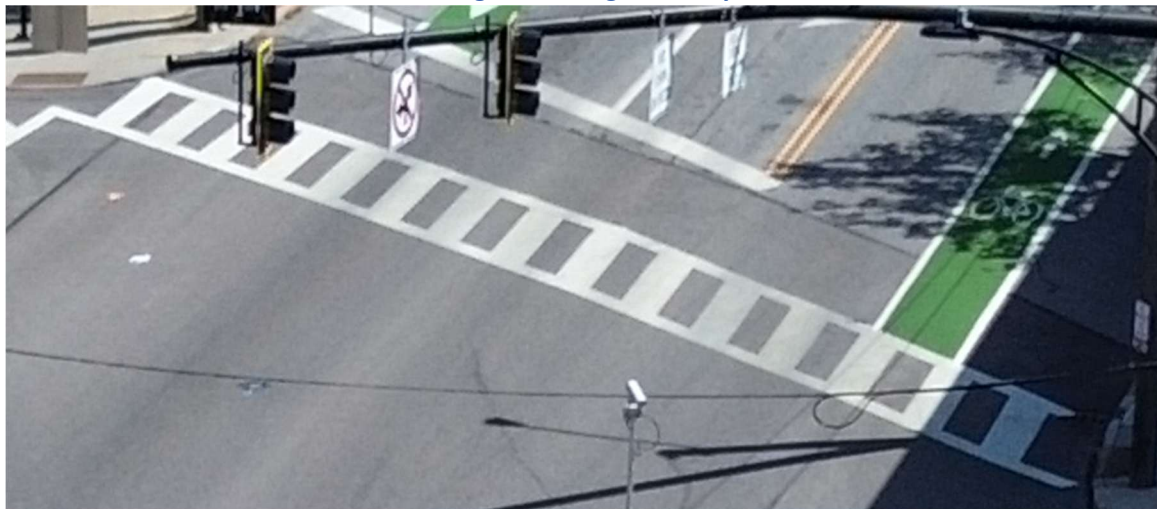
Figure 19 – High Visibility Crosswalk

High-visibility crosswalks use bold pavement markings—such as continental (bar) or ladder-style striping—that are more prominent to approaching drivers than standard parallel lines. These markings enhance pedestrian safety by increasing driver awareness of crossing activity, improving yielding compliance, and providing clearer guidance for pedestrians on where to cross. Research has demonstrated that high-visibility crosswalks can reduce pedestrian crashes at uncontrolled locations by up to 40 percent, making them a proven, cost-effective countermeasure for improving safety for vulnerable road users.
